Manhole Inspection Summary

Manhole # S25G__006MH

Location Address: **1058 W Carrollton**

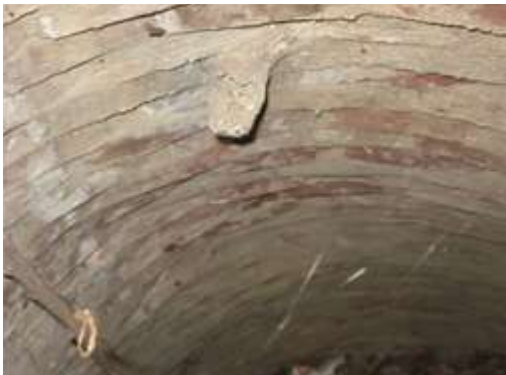
Misc 3

broken blow out

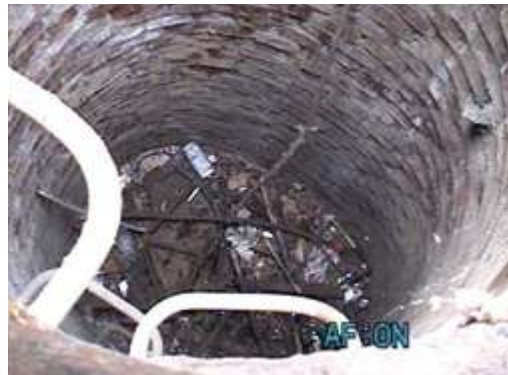
Defect 6

Condition: ☐ Sound ☐ Cracked ☐ Root Intrusion ☐ Deteriorated ☐ Leaks ☒ **Debris**

Channel Debris

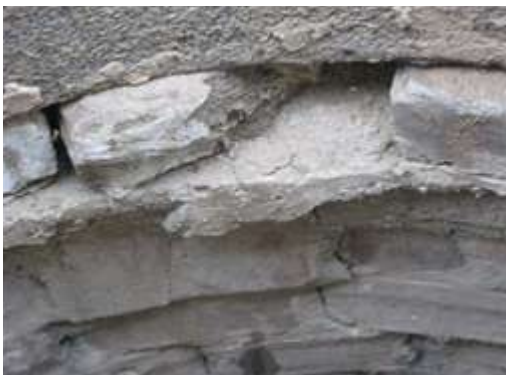
Defect 5

Condition: ☐ Sound ☒ **Cracked** ☐ Root Intrusion ☒ **Loose Brick** ☒ **Deteriorated**

Condition: ☐ Sound ☒ **Cracked** ☐ Root Intrusion ☐ Loose Brick ☐ Deteriorated

cracks in chimney and corbel

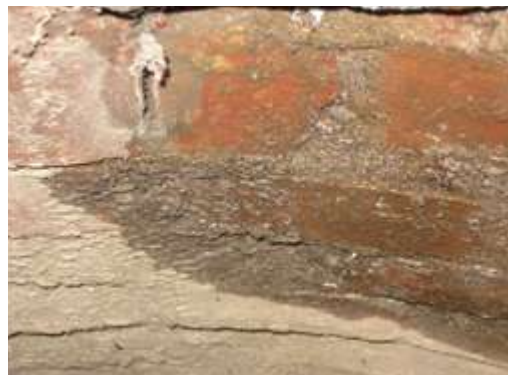
Defect 4

Infiltration: ☐ None ☒ **Joint** ☐ Cracks ☐ Mortar ☐ Roots ☒ **Wall**

joint/wall infiltration at corbel

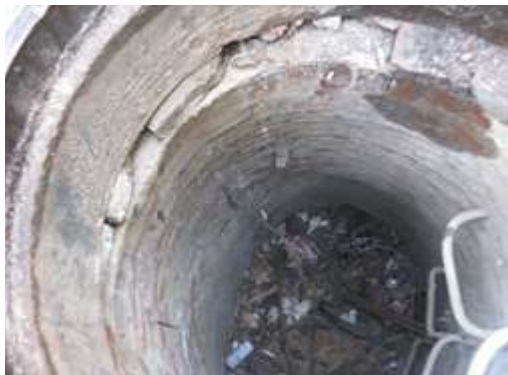
Defect 2

Infiltration: ☐ None ☐ Joint ☒ **Cracks** ☐ Mortar ☐ Roots ☒ **Wall**

Loose bricks and deteriorating chimney,
infiltration at cracks & wall

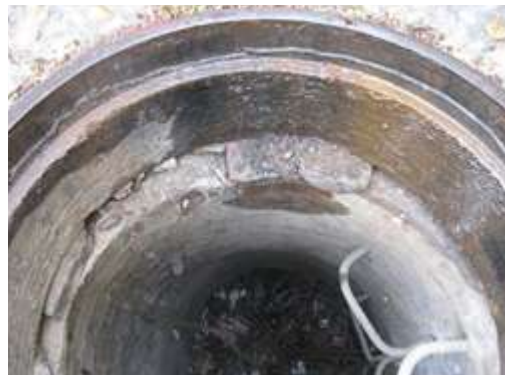
Defect 1

Offset: **3** (in.)

3 in offset

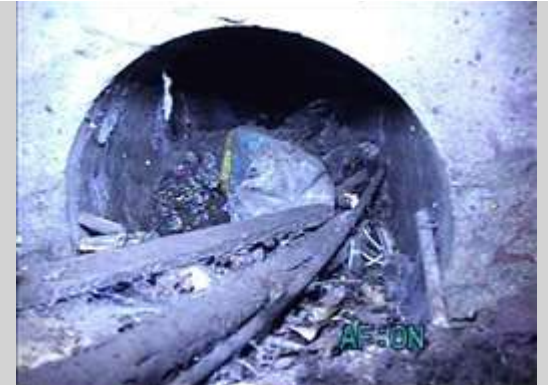
12 O'Clock Outflow

debris in pipe

Deposits: ☐ None ☐ Mud ☐ Sludge ☒ **Debris** ☐ Grease
